Conserving Datchet's Milestone

Report by Datchet Village Society

January 2019

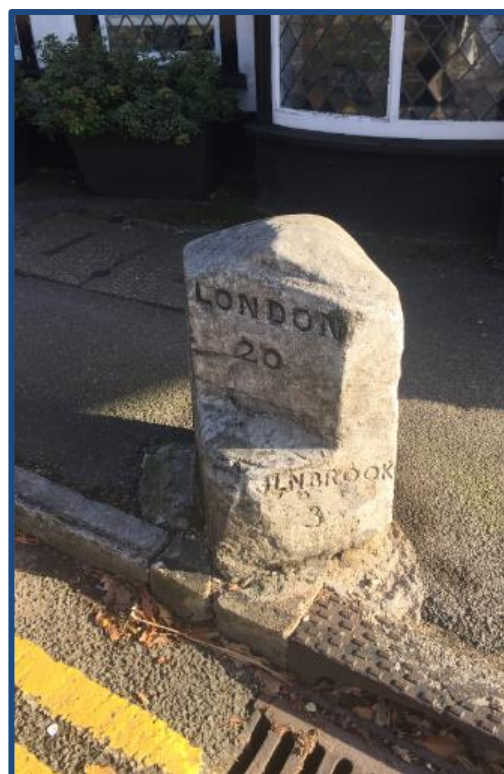
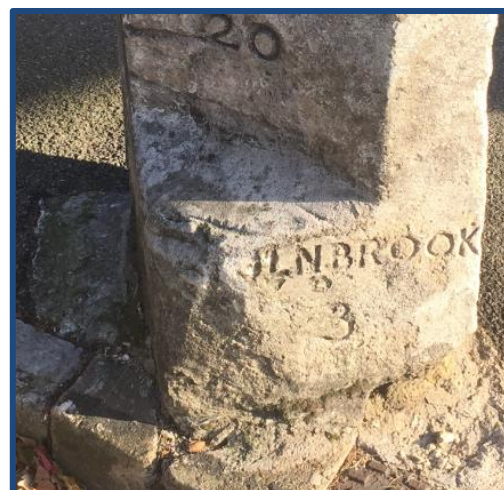
The milestone, carved from Portland stone, was knocked over and damaged by a motor vehicle in September 2018. It has been temporarily cemented in place while a decision is made about its future conservation and possible relocation for its own safety.

It is in a parlous state. Milestones are like the roots of teeth; they are very long and are usually set deep below ground. At some point in its history, Datchet's milestone was cut and separated from its deep 'root'. The exact location of the 'root' is not known. There is currently nothing to anchor the milestone in place, making it particularly vulnerable to further damage by vehicular impact. The section of the stone closest to the road has been damaged previously and some of the lettering is missing. This lower section, where it touches the pavement, also suffers from salt-spreading on the road, rainwater sprayed from the gutter, and exhaust pollution. It has no gravel breather margin and the temporary cement repair is also detrimental, causing 'wicking'. In its current location, the milestone is suffering significant ongoing and disfiguring decay. Its location and insecure fixing represent immediate, potential threats to the well-being of this milestone. It is at real risk of damage or loss.

It has been proposed to relocate the milestone in order to protect it, to have it cleaned and conserved and the 'root' replaced.

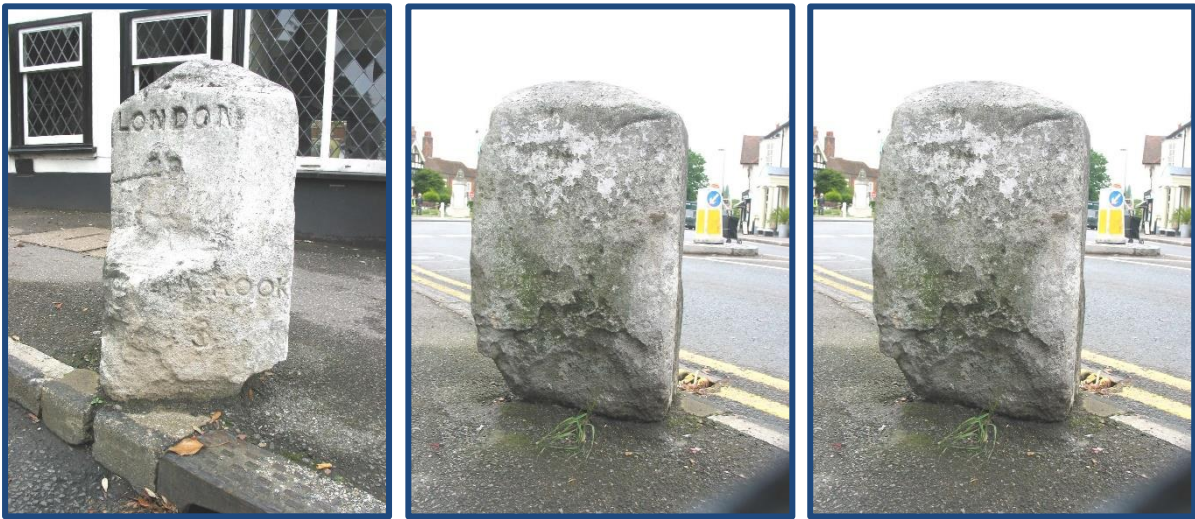
Photos: 2004

By 2004, there were serious concerns about the deteriorating condition of the milestone. Although its base had been eroded on all sides in the past, a chunk of stone had fallen off the bottom right corner and it was being seriously undercut at that point by rainwater sprayed up from the gutter. It used to be whitewashed regularly, as much for preservation as for visibility, but it was feared that coating the area of damage in situ would not solve the problem as the damp would be sealed in and continue to degrade the stone.

At the time, Alan Rosevear, the regional representative of the Milestone Society which keeps a watching brief on restoration and rescue projects all over the country, reported on the stone's condition. He was concerned that it was very likely to fall due to the undercutting, even without further damage caused by motor vehicles. He concluded that it was in a precarious position and was a risk to traffic and pedestrians.

At the time, RBWM's Conservation Department and English Heritage both gave their consent for the milestone to be removed to a new, safer position on the village green. Datchet Parish Council initially approved the move but following a local election, the matter was discussed again. The owner of Church Cottage, also a councillor, was keen that the milestone should not be relocated and offered to pay for the work so that the expense would not be borne by the Parish Council. The milestone was taken away for conservation and replaced in the same position in 2006.

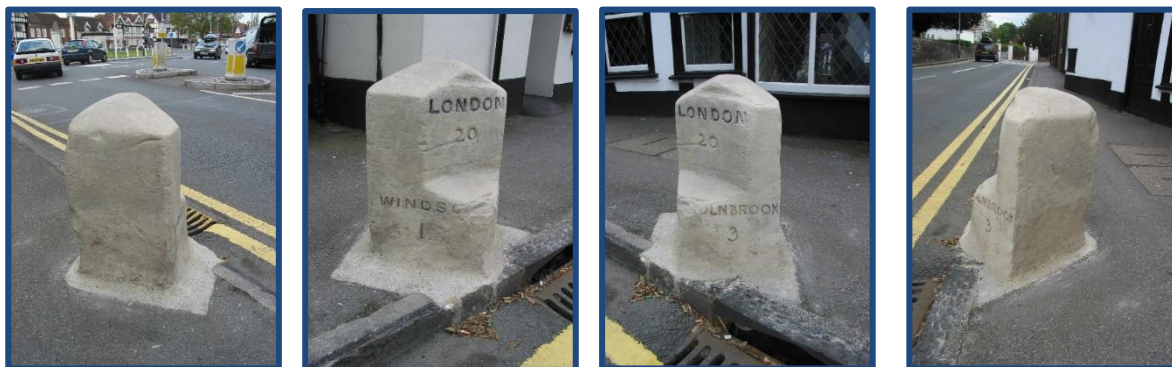
Photos: 2006

In 2018, the milestone was knocked over and further damaged by a van. It has been set back in place temporarily, using modern materials, while a decision is taken about its future.

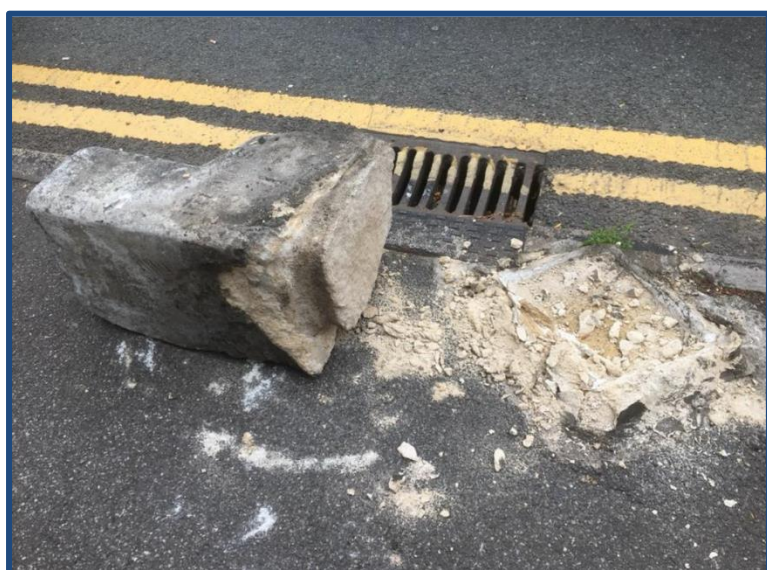
The milestone no longer has its 'root' so very little of the stone sits below ground level. This makes it unstable and vulnerable to vehicular damage, however it is not possible to re-attach a root in its present location.

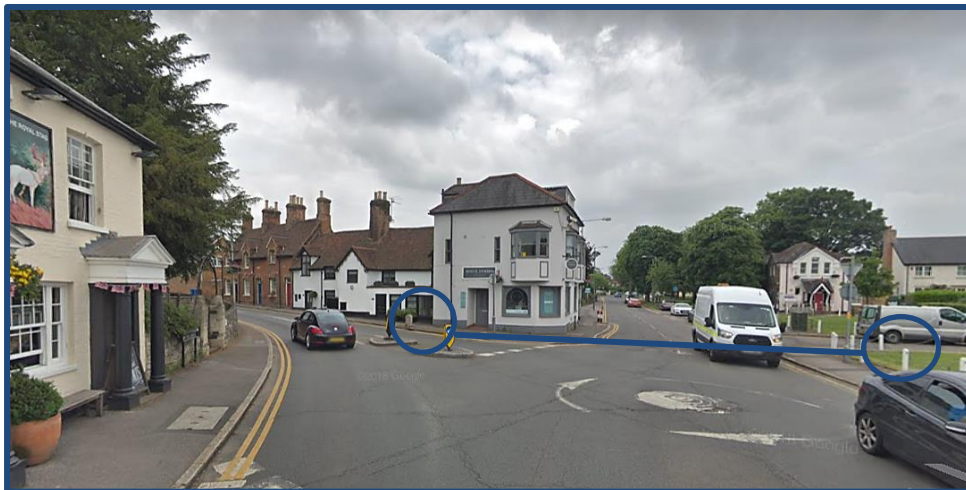
The image from Google Maps, below, shows the current location, circled in blue, on the left and approximate proposed location on the right.

As the milestone is handed, the relocation sites are limited. Datchet Parish Council, in consultation with Datchet Village Society, has located a potential site on The Green, close to the current position but in a much safer place, set back from the road edge.

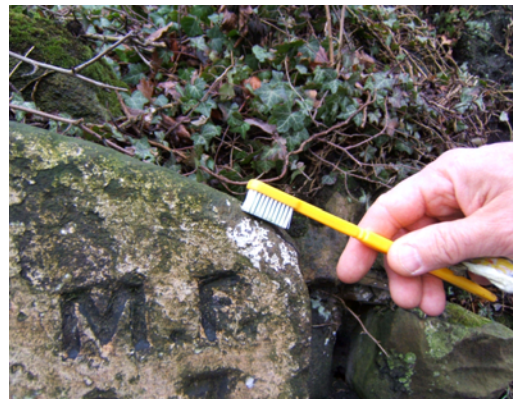
Light cleaning may be all that is necessary as this sample test using nothing more than a toothbrush and water demonstrates.

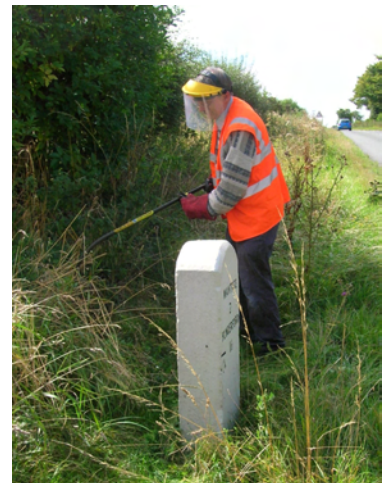
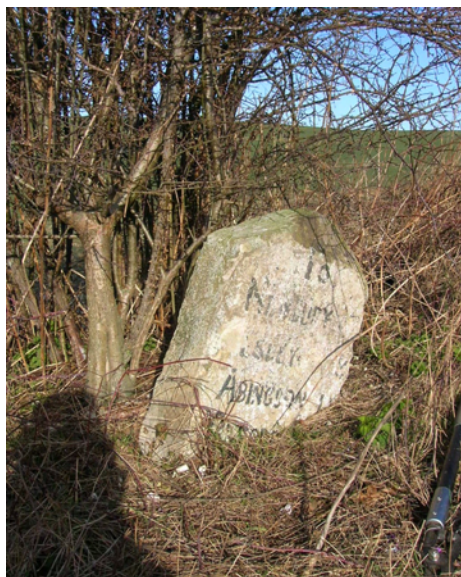
Lost in the undergrowth and severely tilted, this stone needs attention.

4. Re-setting stones;
Stones which have fallen or lean severely should be raised and re-set. Similarly, stones that have sunk or are largely obscured by a rise in the surrounding ground level should also be re-set (see standard specification 'a').

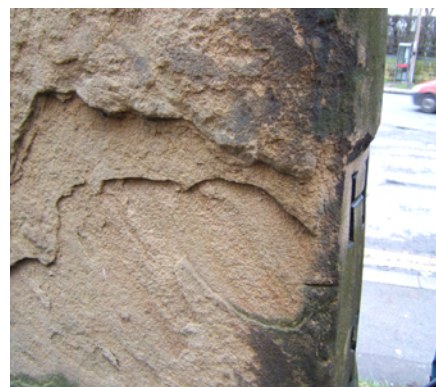
Application of a conservation-grade filling medium around delaminating edges would greatly reduce the rate of decay in this stone.

- Deep voids and cavities and any wide laminations or cracks can be filled with an appropriate conservation-grade filling medium. Rather than attempting to mix a suitable mortar using the basic ingredients of aggregates and binding medium, ready mixed proprietary mortars, based upon Natural Hydraulic Lime (NHL) and aggregates should be used. These products can be built up in layers to fill the deepest of cavities, with each successive layer keyed to improve adherence, while at the same time also allowing featheredge finishing.

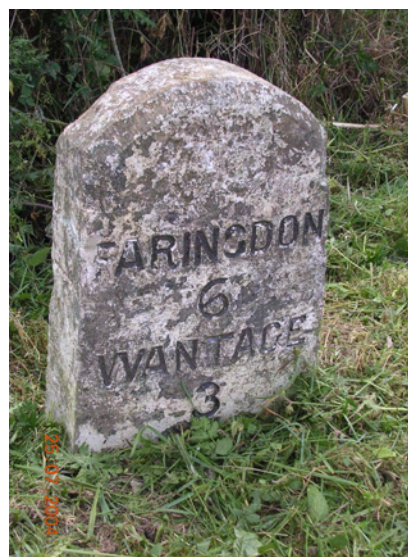
This stone has developed an attractive patina of age which could easily be lost by 'over restoration'. It would be a good candidate for lime wash.

- For all stones, except sandstones rich in silicates (see item 1.1 above), the application of limewash should be given consideration, as this will have been the traditional means by which surface protection and bright decorative finish were achieved. Nowadays prepared and tubbed products are becoming widely available and where successfully applied these provide a good sacrificial / protective coating which reinstates the historic appearance of a limewashed stone. Where the surface of a stone has become very friable, a graded fine aggregate can be added to the first and second coats. The manufacturer's literature will advise further in this regard. Limewash is strongly alkaline and should not therefore be used without a clear understanding of the Health and Safety implications and a careful assessment of the working conditions on any given site. Unlike masonry paints, successful limewashing can necessitate the application of numerous coats, particularly when a stone is highly porous. As the work proceeds, each successive coat also needs careful protection from the weather (including warm sunshine) in order to achieve a satisfactory result (see standard specification 'c' in appendix). The performance of limewash can be varied by the addition of materials such as casein or tallow, both of which are routinely used in the

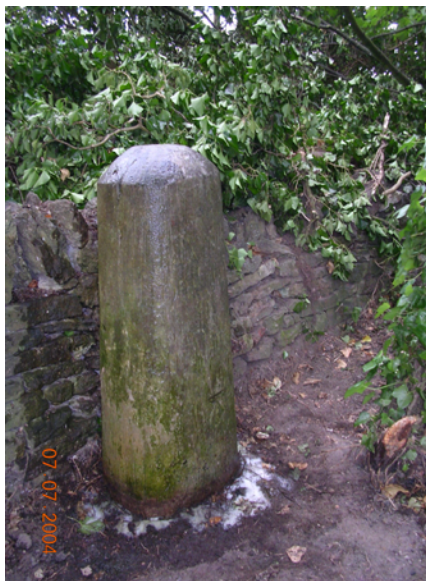
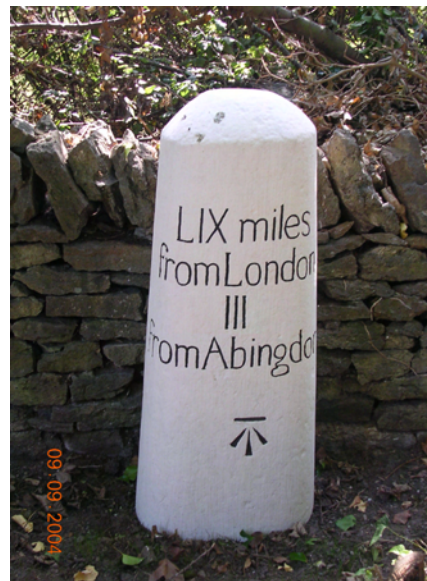
Obscured by shrubbery and heavily contaminated with algae, this hard limestone marker has been very successfully restored by cleaning and repainting with silicate based paint.

- The application of a microporous, silicate-based paint is an acceptable means of both consolidating the surface of the stone and producing a satisfactory decorative finish. These products are both safe and relatively quick and easy to apply and therefore lend themselves well to less skilled user or to working in very remote locations. General guidance for their use is given in standard specification 'd' in the appendix but each manufacturer will give more specific instructions. Pre-treatment with proprietary consolidants should be avoided. In opting to use a proprietary paint system, it must be recognised that one is departing from traditional methods and, in some cases, reversibility can be compromised.

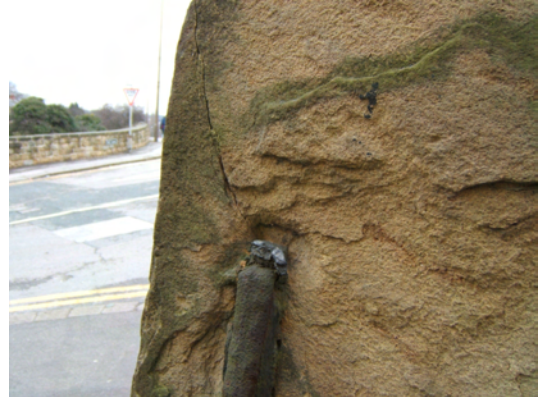
Corroding iron staples may cause fracturing. Removal is a task for an expert.

- Corroding iron staples, cramps and fixings: Iron cramps and fixings are often found in some larger mile markers, where they have been used either as a past repair to fractures or as a means of securing one element to another. If corrosion is severe and particularly if hair cracking is evident in the stone around the locating sockets, the cramps / fixings should be removed and replaced in bronze or stainless steel.

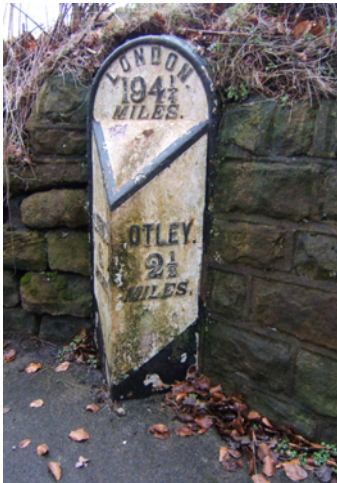
In spite of its very damp location, this marker is surviving well. Repainting in situ is all that is required.

- Remove as much paint as possible using a proprietary paint remover and scrapers. Make sure that the surface is thoroughly washed with clean water on completion.
- Carefully de-rust any corroded fixings with a scraper and wire brush. Where severe corrosion is present between bolts and backing plates, this should be carefully chipped out and the area treated with a proprietary 'rust converter' (available in most automotive stores).
- Wire brush the surface of the iron back to a bright surface and finish with steel wool.
- Mask the backing stone before painting a face plate.
- Apply the following paint specification:
One coat of zinc rich primer followed by one coat of micaceous iron oxide paint and finish with two coats of tractor enamel. Text can be picked out in black enamel.

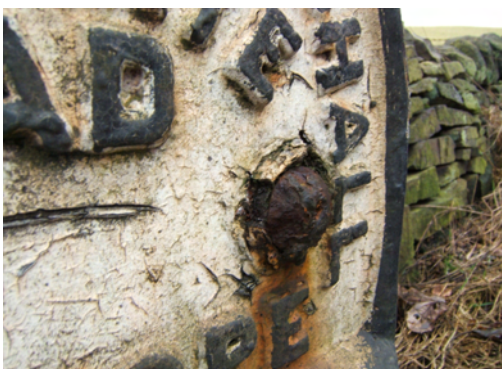
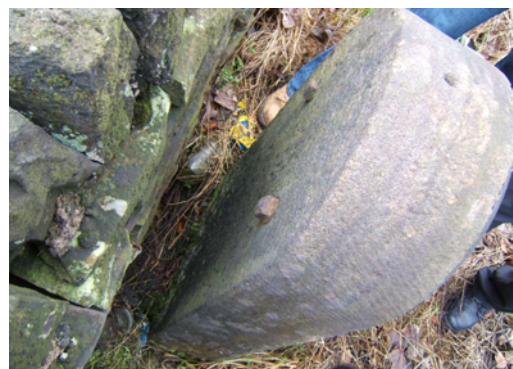
This fixing is corroding severely and might best be replaced. Nuts on back of stone are easily accessible.

If fixings are to be replaced, replica items should be used, manufactured from stainless steel. The fitting of an inert (nylon or similar) washer between the bolt head and the cast iron is recommended.
